TECHNICAL BULLETIN INDEX
Sorted by Bulletin Number
04/03/86

DATE: November 3, 1980
 REVISION DATE: January 17, 1983
 BULLETIN NO.: CC:1
 PRODUCT: 26-3001/2 Color Computer
 SUBASSEMBLY: N/A

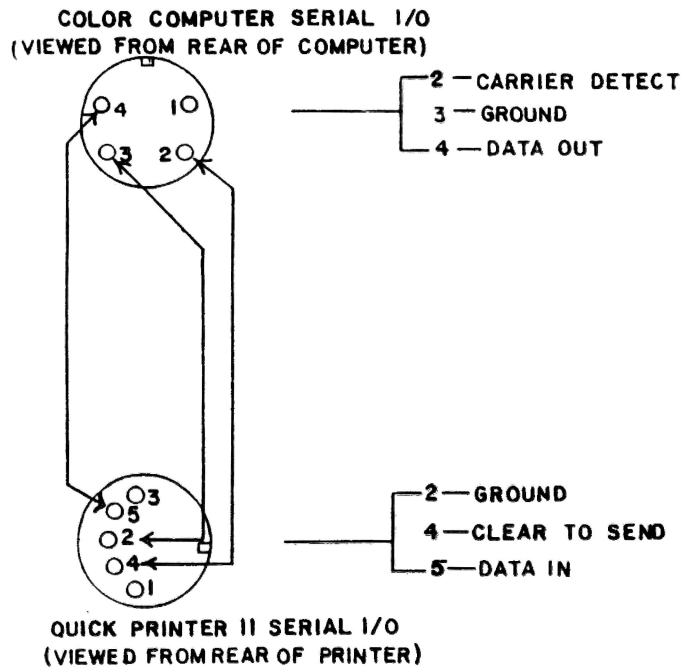
PURPOSE: When connecting a Quick Printer II to the Color Computer, printer only prints one letter and then stops.

The Color Computer Preliminary Documentation concerning RS232 interfacing shows the incorrect pinouts of the RS232 port.

Use the following diagram to interconnect the Color Computer and Quick Printer II.

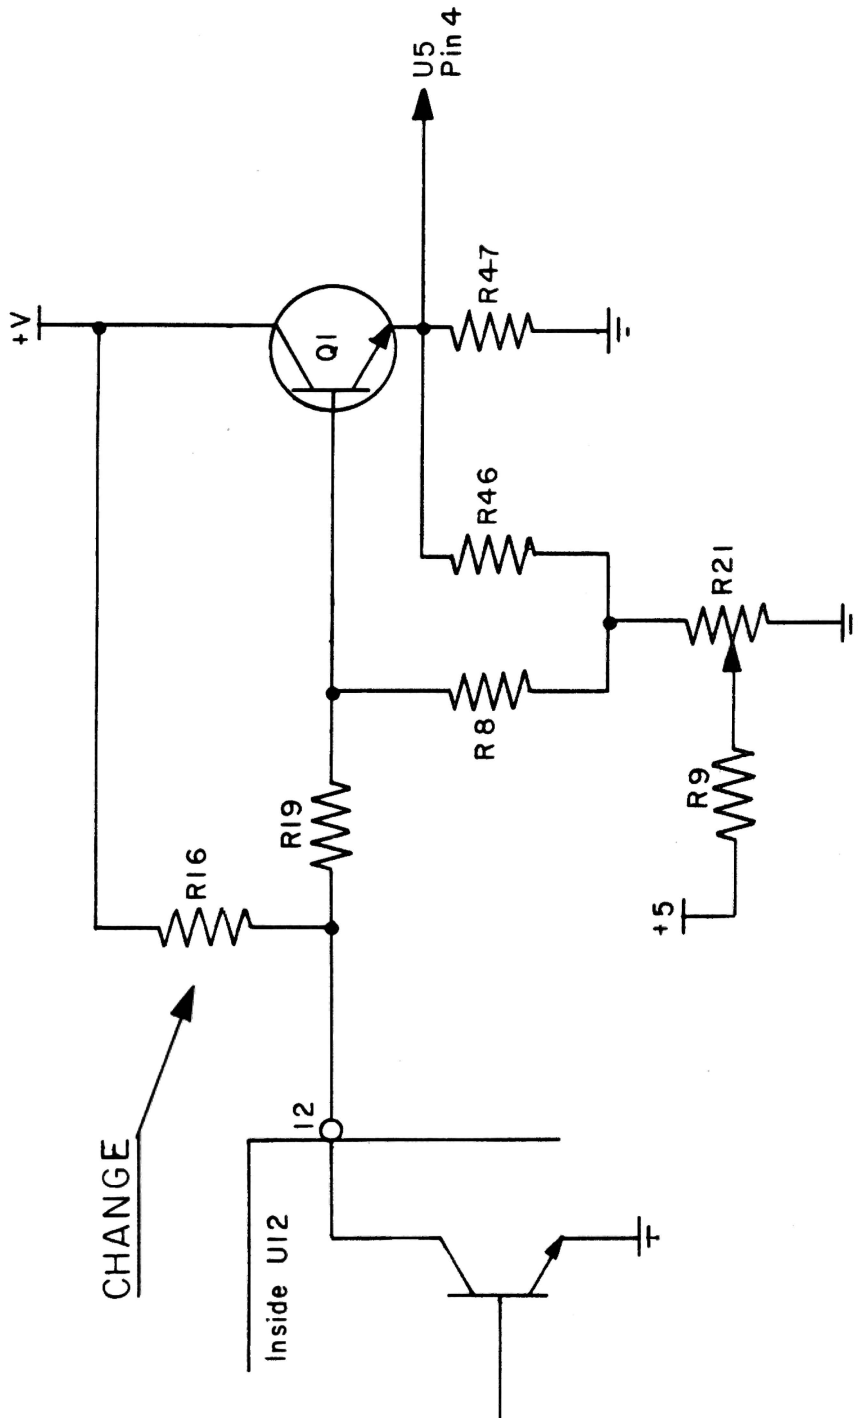
PURPOSE: Replacement ICs for U12 fail. Some ICs work, some don't.

It has been determined that the MC1372 Video Mixer is not actually failing. The problem lies in different drive current capabilities of the output stage of U12, the video mixer. Only hand selected ICs for U12 will work.

Check the value of R16. If it is 3.9K ohms change it from 3.9K ohms to 3.3K ohms (National Parts # AN-0230EEC). This will increase the drive current available from U12, and allow all presently available MC1372 ICs to work.

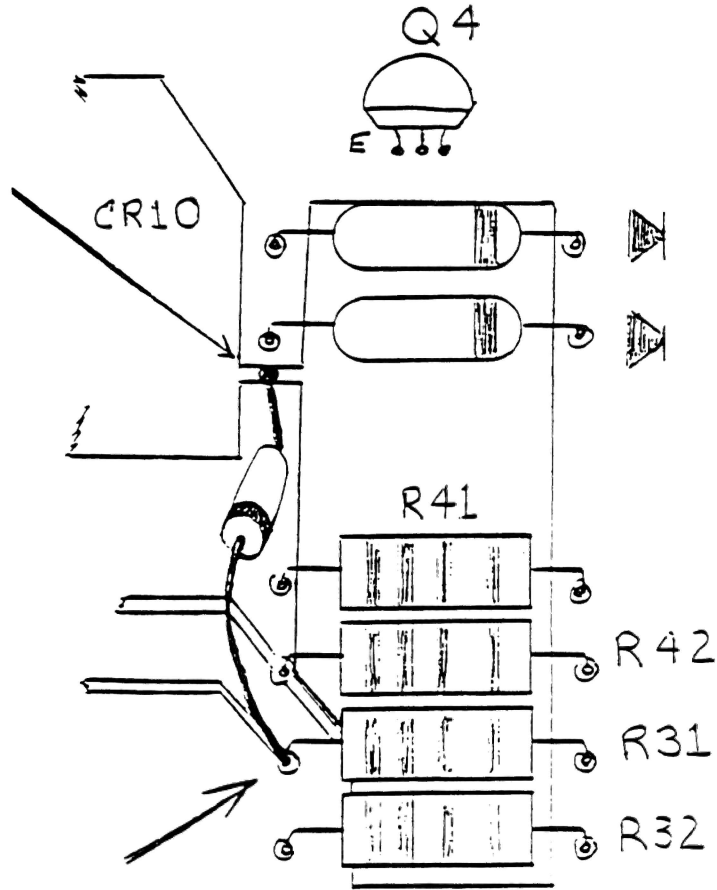
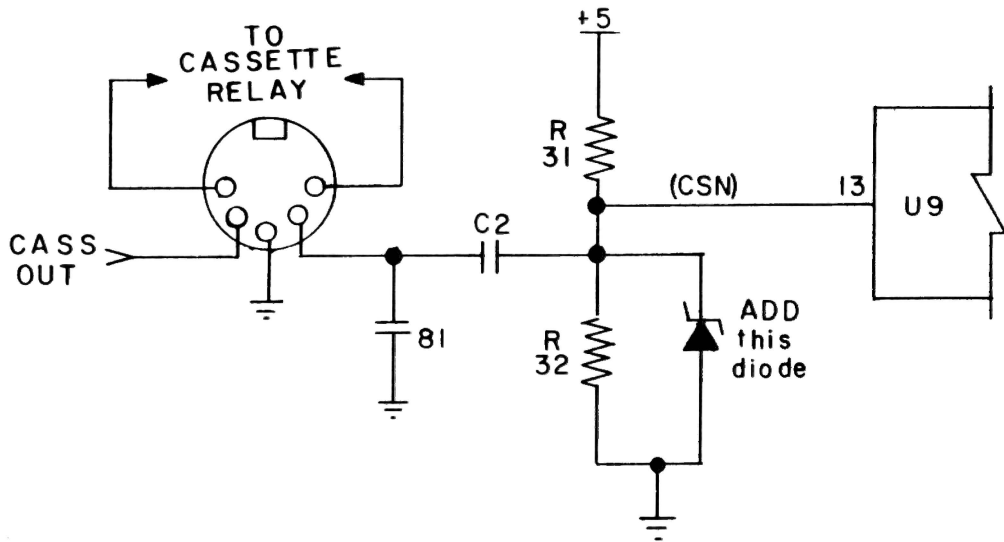
If the CSN signal is greater than 5 volts peak-to-peak, U9 may be damaged. To prevent damage to U9, add a Zener diode to the CSN line to clamp it to 5 volts peak-to-peak.

- (1) Replace U9 (National Parts number AMX-4585).
- (2) Install a 5.1 volt Zener diode (National Parts number ADX-1211) at the junction of R31 and R32. Install the diode with the CATHODE (banded) end at the junction of R31 and R32, and the ANODE end to ground.

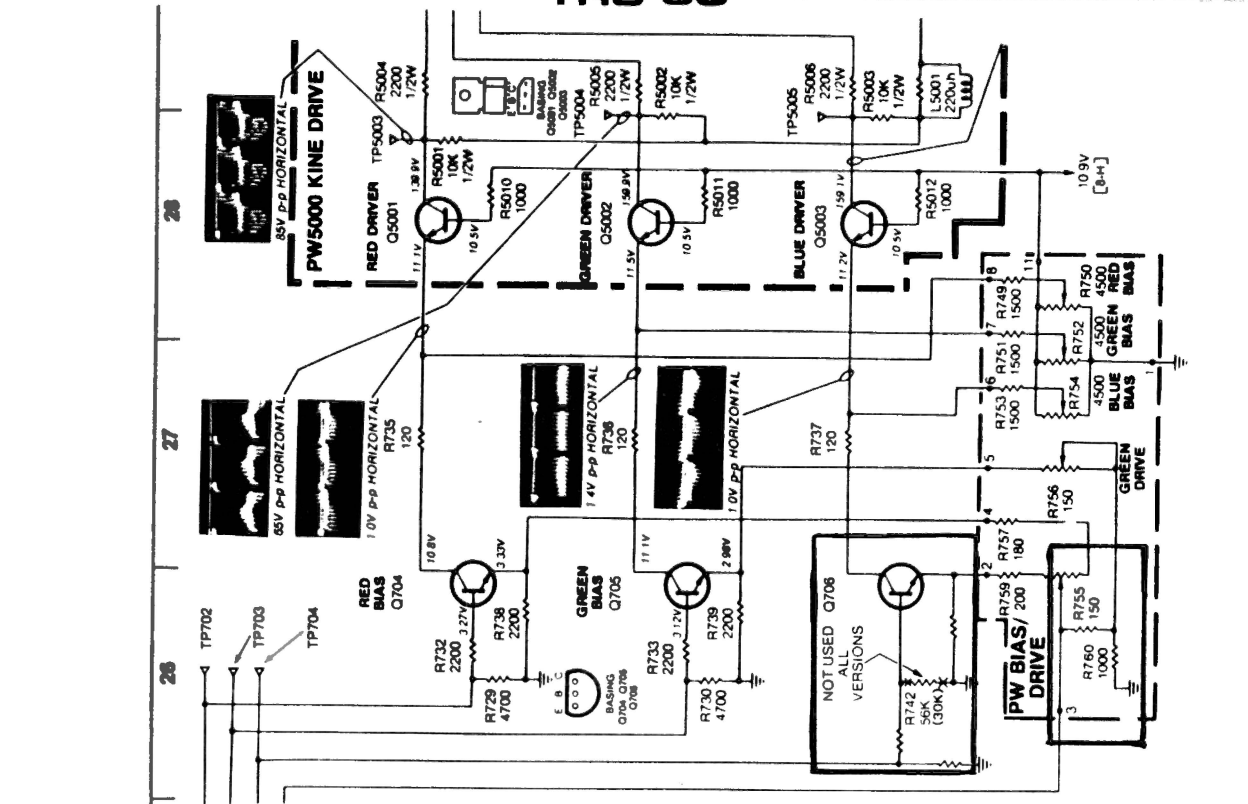
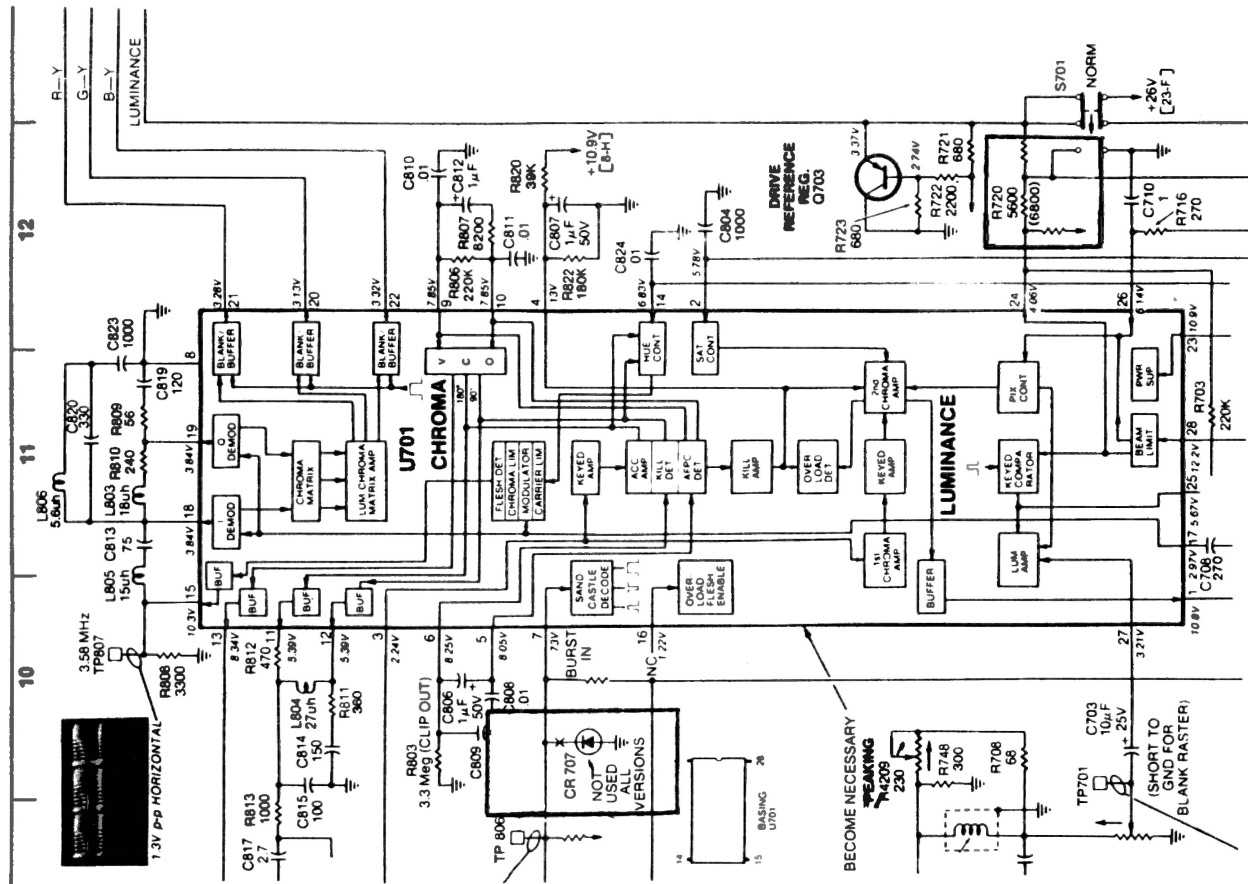
RCA has used 9 different variations of the Luminance/Chroma processor chip (U701) in the assembly of the CTC-107 Color Television Receiver chassis. During repair, parts availability may require installing a different version of the IC than was originally installed in the chassis. It may be necessary to change, install, or remove several other parts to make the supplied IC work in the circuit.

U701 Rev.	CR707 (R720 on main PCB	R742)	R755 (on bias/drive PCB)	R760
-1	OMIT	5.6K	OMIT	150	OMIT
-2	OMIT	5.6K	OMIT	150	1K
-3	*****THIS REVISION OF U701 IS NOT USED*****				
-4	OMIT	5.6K	OMIT	150	OMIT
-5	OMIT	5.6K	OMIT	OMIT	OMIT
-6	031 (SEE TEXT)	5.6K	56K	150	OMIT
-7	OMIT	5.6K	OMIT	150	OMIT
-8	OMIT	6.8K	30K	150	OMIT
-9	OMIT	6.8K	30K	OMIT	OMIT
-10	OMIT	5.6K	OMIT	150	OMIT

For your information, the following page highlights the schematic areas effected by this modification.

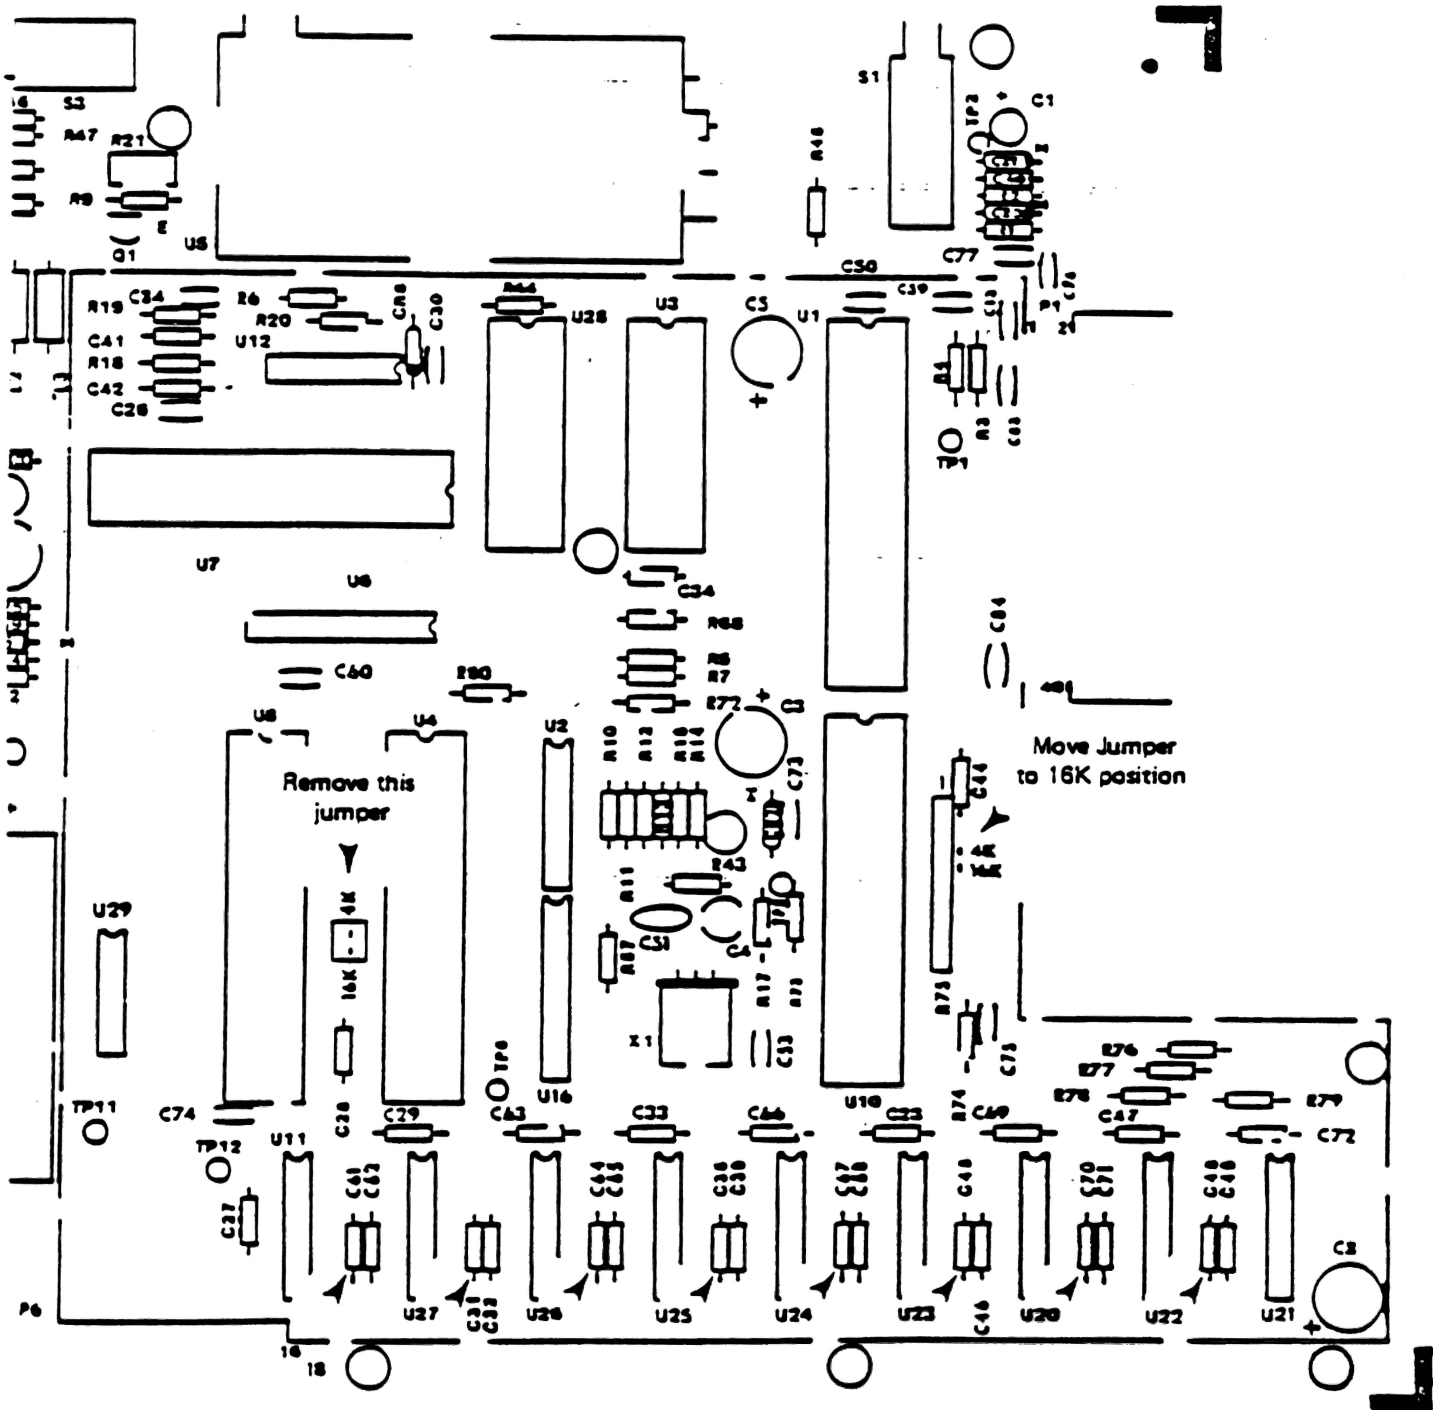
FIGURE 1
 LOCATION OF CAPACITORS TO BE CUT
 ('D' AND 'E' BOARDS IDENTICAL)

The lines coming from pins 2 and 3 of the PIA are labeled RSW (Right SWitch) and LSW (Left SWitch) on the schematic. The RFI suppression on the joystick circuits add capacitive loading to these two lines. This, along with the added usage of pin 16, causes intermittent failures of the keyboard. Lowering the value of the capacitors on these lines improves the response.

DELETE CAPACITORS : C81, C31, C64, C35, C67, C45, C70, and C48.

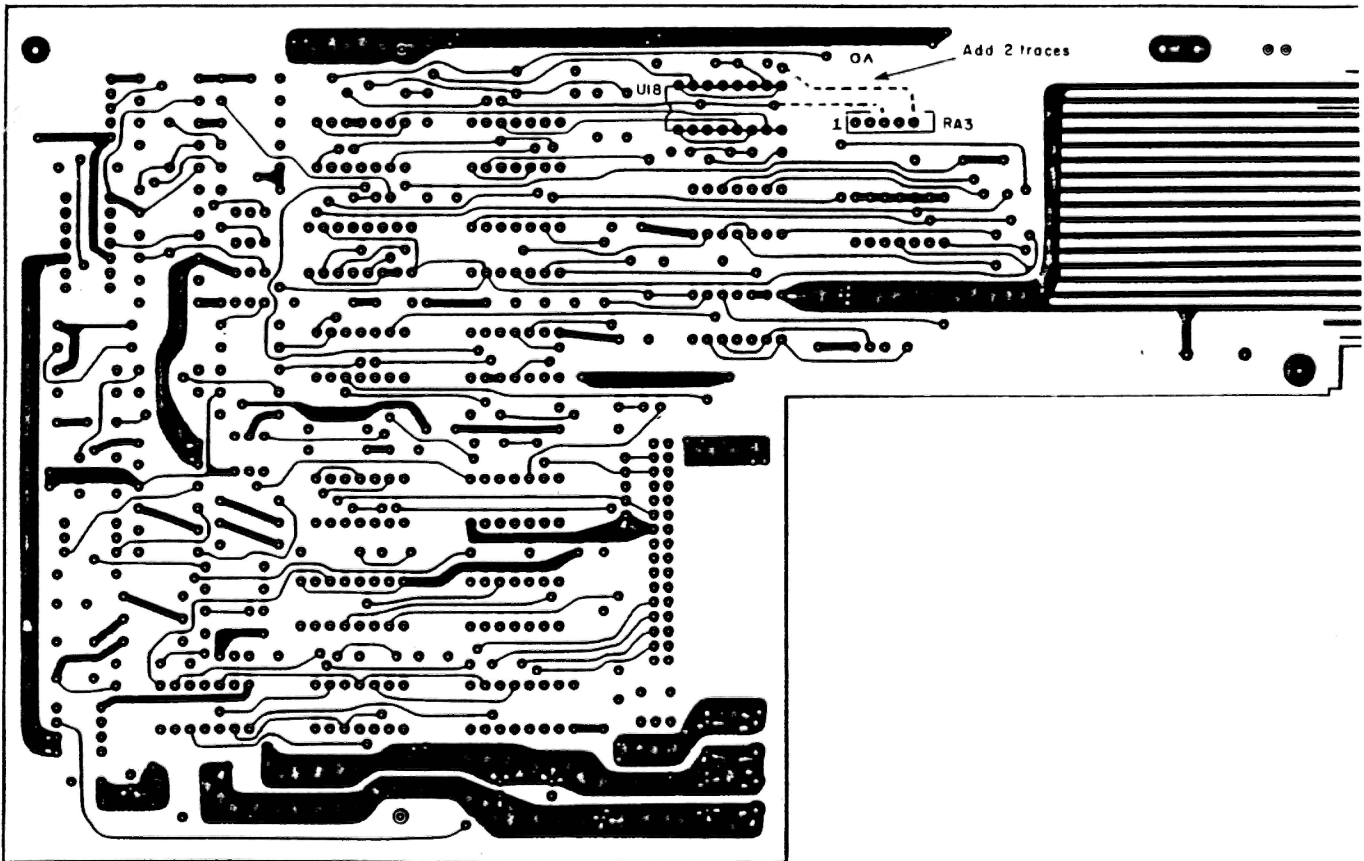
FIGURE 1

PURPOSE: Missing traces on Drive Logic PCB. Symptoms may be intermittent, and include drive not ready, drive write protected, no head stepper action, or I/O errors due to no read data.

Some TEC drive Logic PCBs have been found with traces missing. These traces lead to the pullup resistor pack RA3 located near U18. Resistor pack RA3 supplies pullup resistors for several sections of U16 (74LS33 open collector NOR gate). With the traces missing two sections of U16 have no pullup resistors on their outputs.

- 1) Add a jumper from RA3 pin 5 (the pin closest to the edge card fingers) to the feed through next to U18 pin 8.
- 2) Add a jumper from RA3 pin 3 (the middle pin) to the feedthrough between U18 pins 8 and 9.
