4th Annual Last Chicago CoCoFEST! '95

You now have the E-clock Fix board from the GlenSide Color Computer Club. We thought it would be good for you to know how to install it into your CoCo 3. So here are the instructions to do so.

E-Clock Modification

by Charles C. Bundy IV

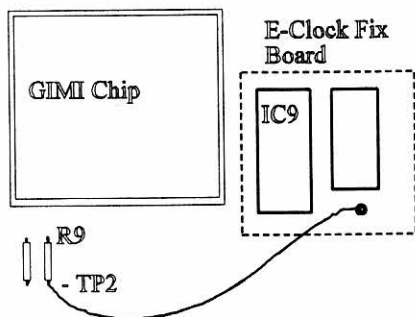
3. Locate IC9 (74LS138, see diagram below), and carefully remove IC9 from the PC Board. Use your preferred method of removal. Do not worry about destroying the chip. There is a replacement supplied with this kit.

7. Then solder the wire from the daughter board to R9 (see diagram below). Inspect for correct connections.
8. Hook up the power supply, keyboard and monitor. Then turn on the computer and make sure you get the 'OK' prompt. If you do, turn off the computer and insert the disk drive controller. Turn on the computer to see if you get the 'Disk Basic' prompt. If you do, try to access your drives. If they work, then your system is ready to be reassembled.

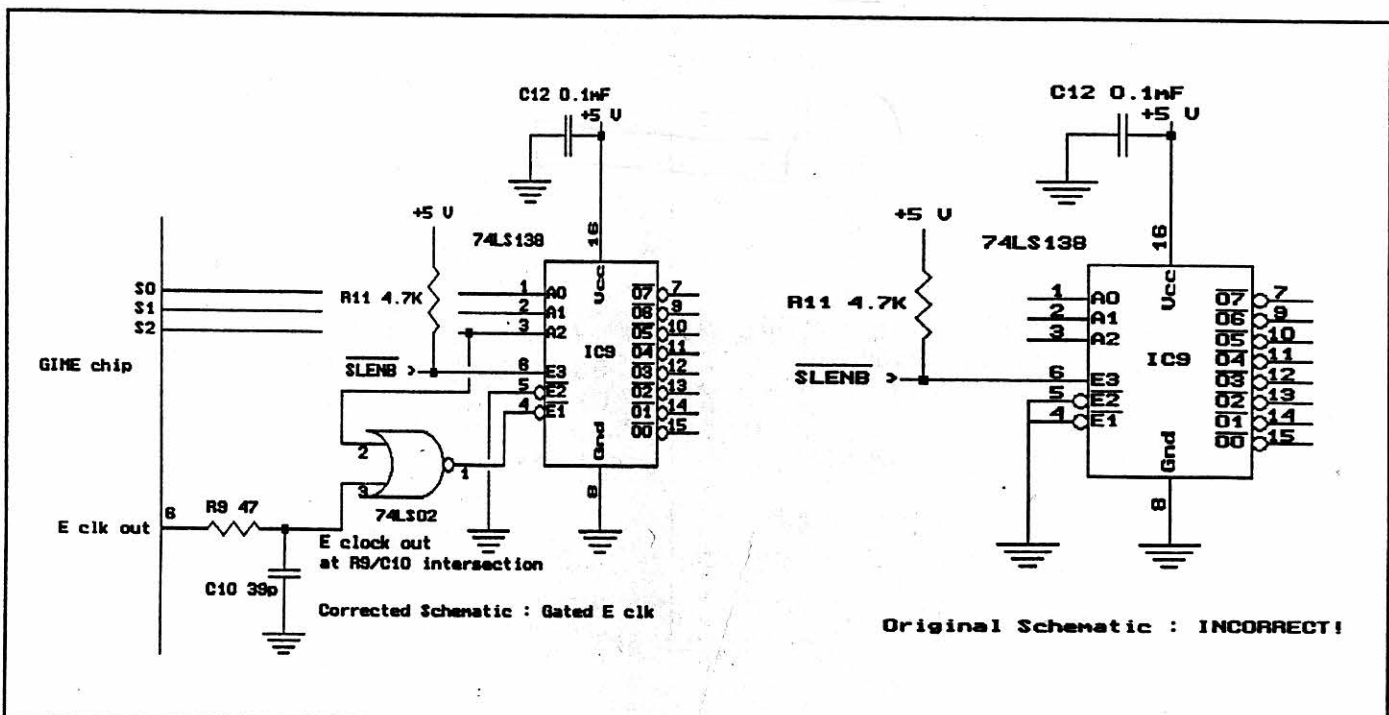
The CoCo III has a slight timing problem with SCS/CTS/ROM selects. This is due to IC9 (74LS138) being selected (i.e. transiting) during an entire E-clock cycle instead of being gated to the READ portion. The tech manual quotes "Due to the nature of the ROMs and in order to prevent data bus contention, the ROMs are enabled only during the E portion of a read cycle." pp 36. This is blatantly false when you look at IC9 it has both *G2A and *G2B and G1 mux selects tied wide open! The fix came from the Motorola 8-bit Microprocessor Handbook Data sheets on the MC6883 SAM (GIME's father :-)).

Take a 74LS02 NOR gate and tie one input to pin 3 of

IC9. Cut the connection between *G2A and ground. Tie the NOR gate output to *G2A of IC9 (pin 4). Tie the other NOR gate input to the E-clock output at the intersection of R9 (47ohm resistor) and C10 (39pF capacitor). R9 is coming from pin 6 of the GIME chip. Make sure you tie pin 14 of the 74LS02 to pin 16 of IC9 (+5v) and pin 7 of 74LS02 to pin 8 of IC9 (Gnd). This is not something for the weak of heart to try! At the very least you will have to remove the motherboard from the case (unless you clip IC9's little leg!) and cut a trace on the bottom of the motherboard. I cut/desoldered IC9, replaced it with a socket and built a little daughterboard which held a new IC9 plus 74LS02.
