TECHNICAL BULLETIN INDEX
Sorted by Bulletin Number
04/03/86

DATE: November 3, 1980
 REVISION DATE: January 17, 1983
 BULLETIN NO.: CC:1
 PRODUCT: 26-3001/2 Color Computer
 SUBASSEMBLY: N/A

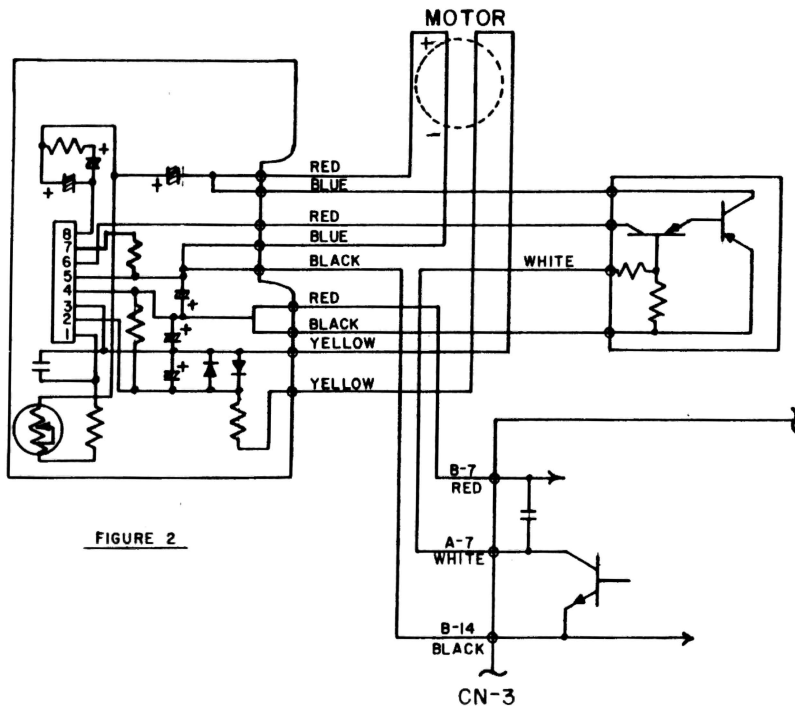
FIGURE 2

Figure 2 is the wiring diagram for the Motor Control/Satellite PCBs as used in Phase 1. Note that the RED wire is connected to pin B7 of CN-3, the WHITE wire is connected to pin A7 of CN-3, and the BLACK wire is connected to pin B14 of CN-3.

- (1) ORIGINAL board being replaced with PHASE 1 board -- Remove BLACK wire from pin A7 of CN-3 and insert it into pin B14 of CN-3. Plug WHITE wire from PHASE 1 board into pin A7 of CN-3.

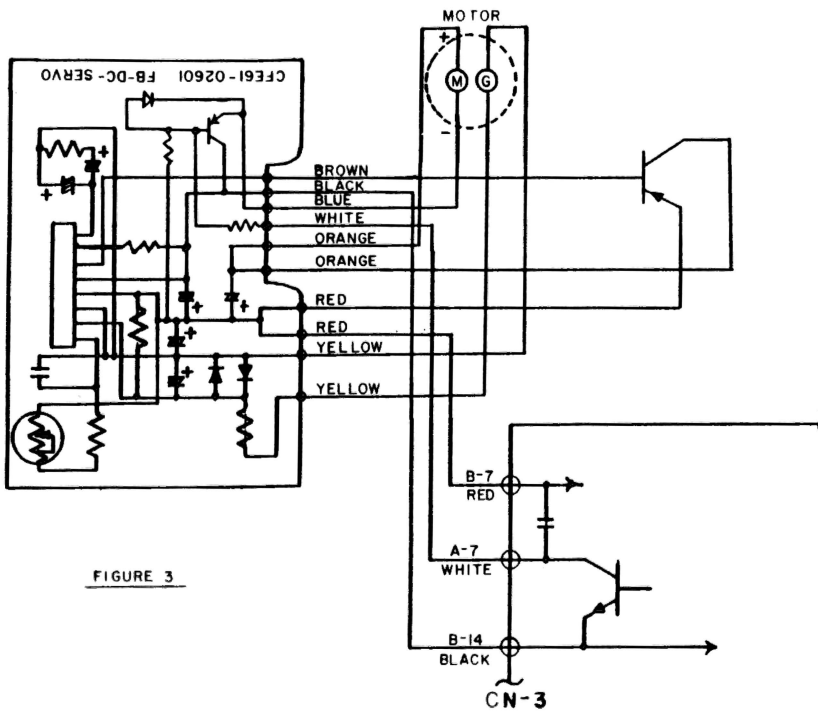
FIGURE 3

Figure 3 is the new Motor Control PCB as used in Phase 2. Note that the RED wire is connected to pin B7 of CN-3, the WHITE wire is connected to pin A7 of CN-3, and the BLACK wire is connected to pin B14 of CN-3.

- (2) ORIGINAL board being replaced with PHASE 2 board -- Remove BLACK wire from pin A7 of CN-3 and insert it into pin B14 of CN-3. Plug WHITE wire from PHASE 1 board into pin A7 of CN-3.
- (3) PHASE 1 board being replaced with ORIGINAL board -- No wiring changes are necessary, but **DO NOT** remove the satellite PCB unless it is **PROVEN** defective. The unit must remain as a PHASE 1 configuration.
- (4) PHASE 2 board being replaced with ORIGINAL board -- **DON'T!!** Replace the PHASE 2 board **ONLY** with the PHASE 1 assembly, or another PHASE 2 PCB.
- (5) PHASE 1 (or 2) board being replaced with a PHASE 2 (or 1) board -- No wiring changes are necessary.

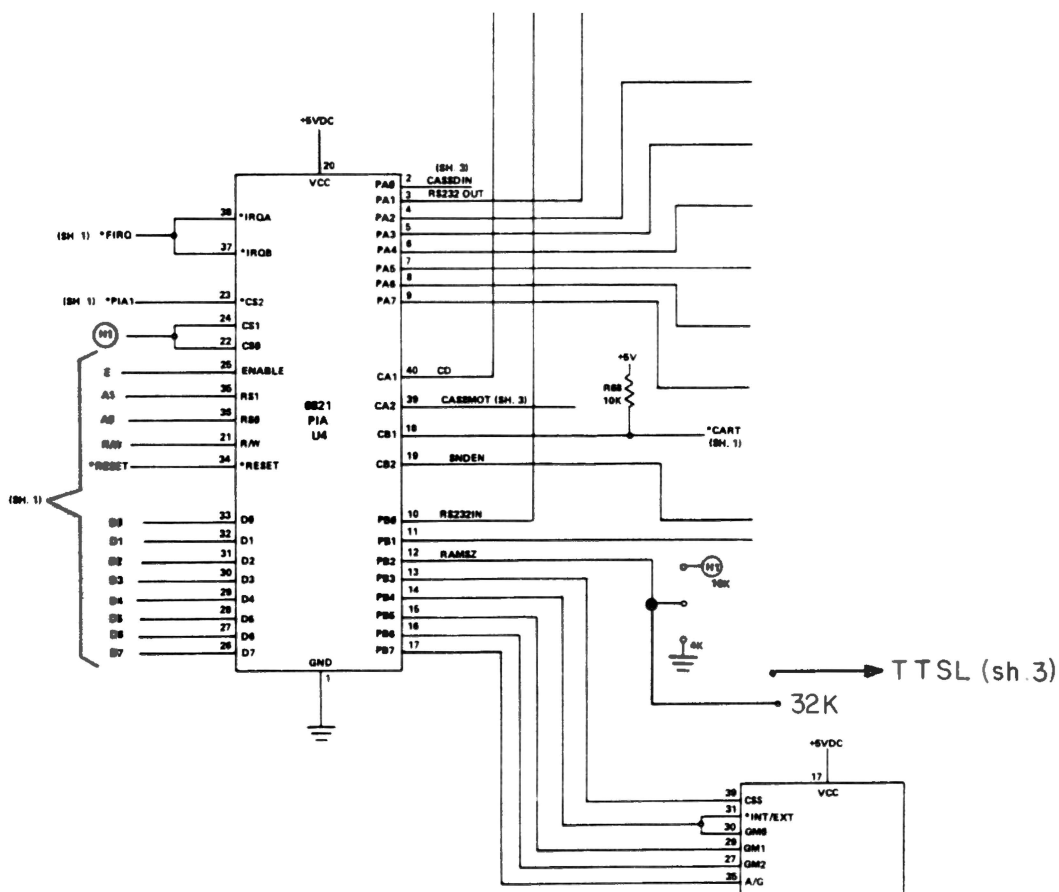
(2) The Color Computer Technical Reference Manual contains the schematic for the Revision 'E' circuit board. Sheet 2 refers to the signal "TTSL (SH. 3)" which doesn't appear on Sheet 3. The enclosed Figure 1 shows the corrected schematic.
